The HUMS2025 Data Challenge Dataset

Wenyi Wang[1], David Blunt[1] and Nader Sawalhi[1]

[1] *Platforms Division, Defence Science and Technology Group, Melbourne, Victoria, Australia*

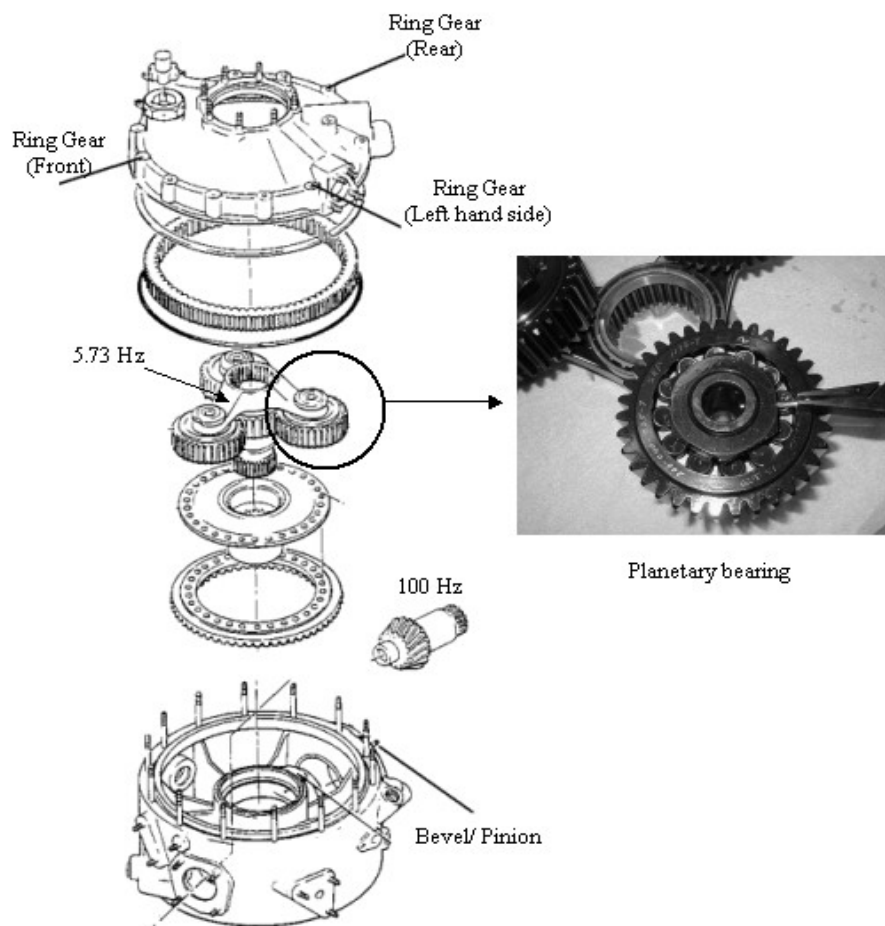
Figure 1: Bell 206B-1 (OH-58) main rotor gearbox (three-planet version). The four-planet version was used in the test. Four sensor locations are indicated in the figure.

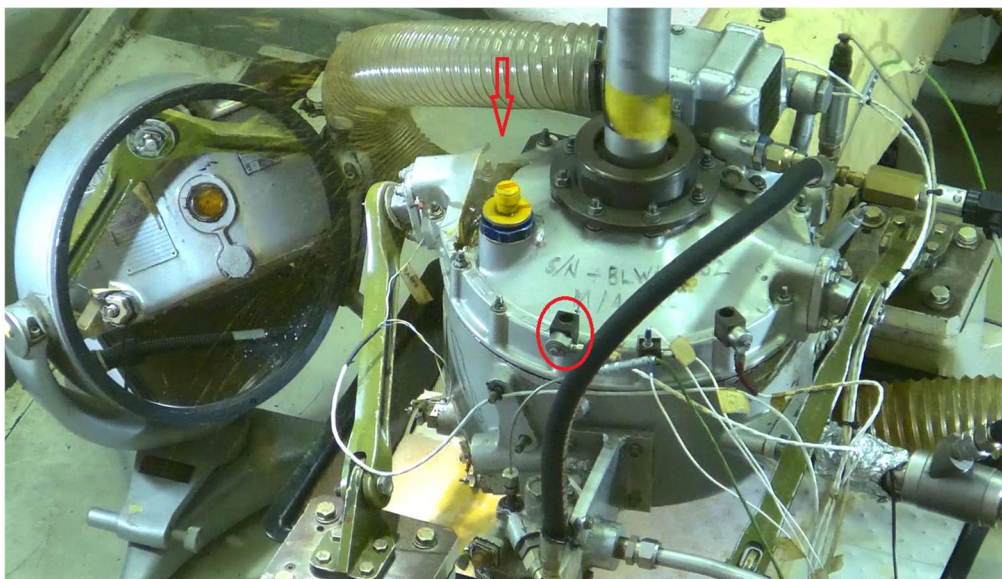
Figure 3: The test article with the location of the casing crack indicated by the red arrow. For reference, the Ring-Front (RF-2) vibration sensor is circled in red. The mirror on the left-hand side of the picture was used to have visibility of that side of the gearbox from the control room.

The upper casing fatigue crack appears to have initiated in the spline that locates/fixes the ring gear in the upper gearbox casing. The crack then propagated through to one of the studs that secure the upper casing to a gearbox support strut. A secondary crack then grew from the top edge of the spline into the upper casing above the ring gear spline and this ultimately resulted in an overload-induced fracture that caused a section of the casing to break away. Note that the ring gear itself was still intact so that the planetary gear set was still holding together. It is important to point out that this casing crack has no bearing on the quality of the gearbox because the test gearbox was (*a*) retired from service and no longer fit to fly; and (*b*) subjected to severe overload (125% and 150% of the rated continuous torque) for most part of the test in order to accelerate the spall progression.
